ENGINEERING FAILURES AND THEIR LESSONS

By EDWARD GODFREY

Copyright, 1924,
By
Edward Godfrey

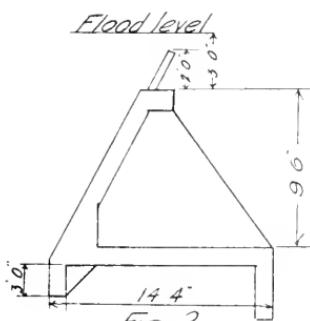
Fig. 2.

FRONT ELEVATION AND SECTION THROUGH THE WASHOUT UNDER THE PITTS FIELD DAM.

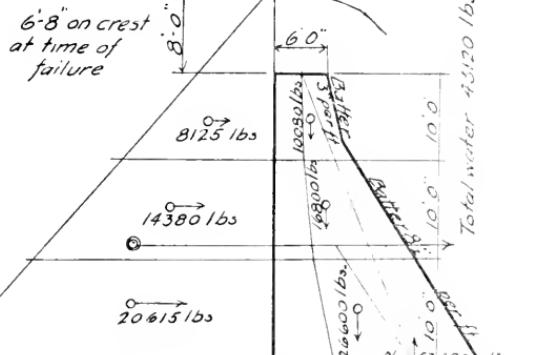
Fig. 5.

Section of Lower Tallasseee Dam - Tallassee, Ala.
This is a stone masonry dam.

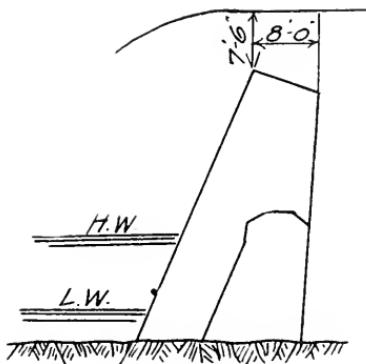
Fig. 6 is another dam which failed. (See *Engineering News*, Jan. 9, 1902.) This one is .71 of the height in width of base.

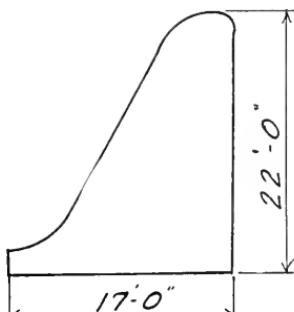
Fig. 7.

Fig. 7 is the section of still another dam which failed. (See *Engineering Record*, May 9, 1908.) The account of this failure is given in *Engineering Record*, June 27, 1908. Fig. 8 is from *Engineering Record*, July 11, 1908. This is a sketch given in connection with a letter of mine. The following is quoted from that letter:

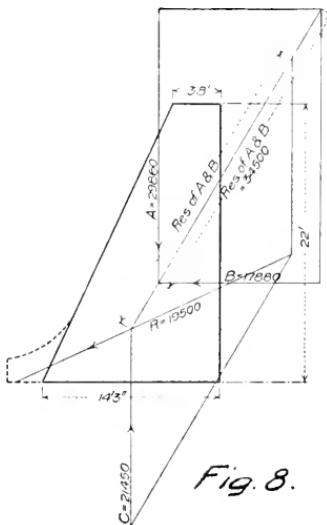
Fig. 8.

"Why should accidents of this nature be put in the unusual class? Is it not a usual thing for water to percolate through dams and reservoirs? What can be done besides wasteful underdrainage to stop it? Watertightness under the most favorable conditions is extremely difficult of attainment. Why, then, are not dams designed with a view of maintaining their stability in the event of their not being perfectly watertight? Why do books on dams, some of them of very pretentious proportions, omit altogether even mention of the possibility of the water working under a dam and supplying a lifting pressure that not only may lift half or more of the weight of the dam, but also acts to lubricate it to allow the blocks to slide out? Instead of long discussion of the "theoretically correct" cross section of a dam, books on the subject would do well to say something of a practical nature on how to make a dam that will dam.

"The dam above referred to is described in the *Engineering Record* of May 9, 1908, and the cross section is given. I have traced the same, leaving out the curves to simplify the calculations, and showing dotted the projection

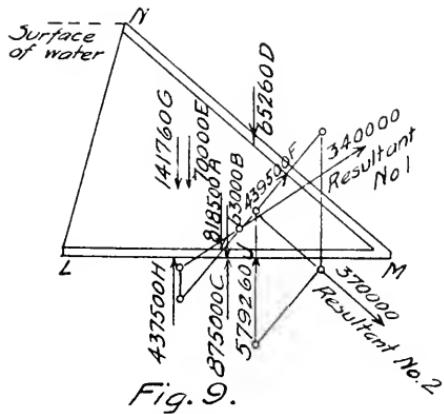
In *Engineering-Contracting*, Feb. 1, 1911, a new style of dam was proposed. This is a hollow dam consisting of a horizontal slab and an inclined slab meeting in V-shape with counterforts between, the water being on the side of the opening of the V. In the issue of March 8, 1911, of the same periodical I pointed out the danger of designing dams of this character, using the cross section proposed as an example. The sketch accompanying that letter is shown in Fig. 9. The following is quoted from my letter:

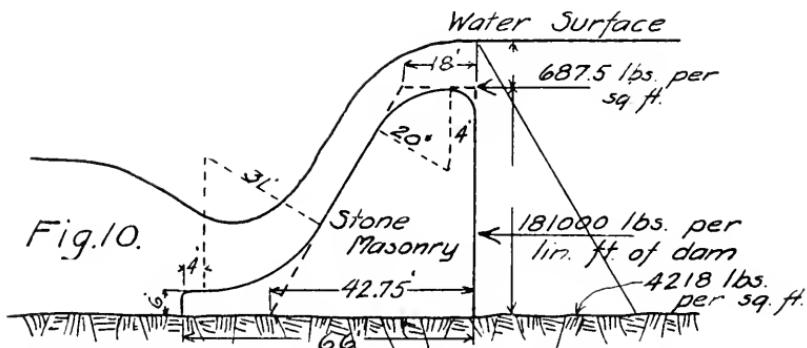
Cross-section of Austin Dam with assumed Condition of Flow at time of Failure.
(Cross-sectional area nearly 2200 sq. ft. Weight of dam per lin. ft. 308000 to 330000 lbs.)

at the toe, as being of no importance structurally, because it is too thin to take the shear, if the dam should rise on the toe. Force A is the weight of a foot of the dam; force B is the horizontal pressure, assuming the water to overtop the dam two feet; force C is the upward pressure of the water under the dam, with a head of 24 feet. Force R is the resultant of A, B, and C. It is seen that this resultant passes clear outside of the base. If the water overtopped the dam by a less amount, of course the resultant would fall closer to or within the base; but a crest of this amount would not be unusual in a flood. The first impulse of this dam would be to rise on the upstream side. This would break it up and allow the lubricated blocks to slide out.

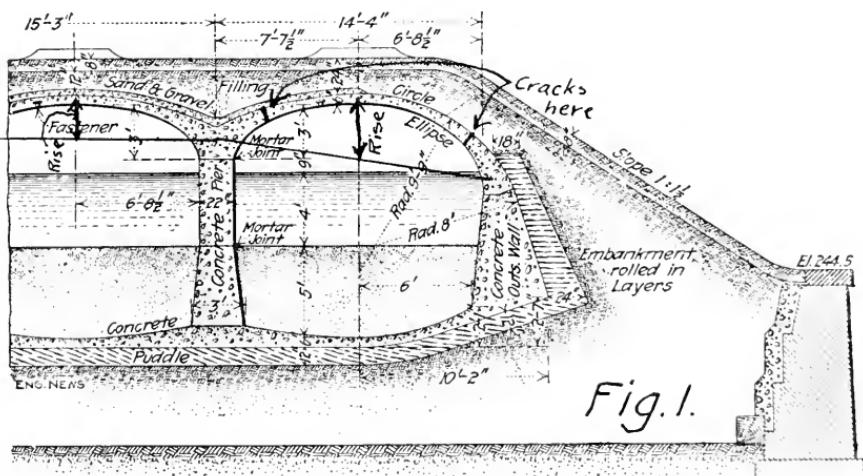
Figure 1 is a cross section of this filter roof. It is seen by this sketch not only that the abutment of the outer arches is rather light but, what is more significant, the effective rise of the outer arches is much greater than that of the interior arches. The effect of this condition would be to force the outer arches upward and break the same, due to the inability of the outer arches to resist the thrust of the inner arches. Two arches of the same span and loading will have thrusts inversely as their rises, hence the outer arches in this construction will exert a thrust much less than that required to maintain equilibrium in the interior arches. These facts were not pointed out in a long account of this failure. They are the real and about the only lessons of the failure.

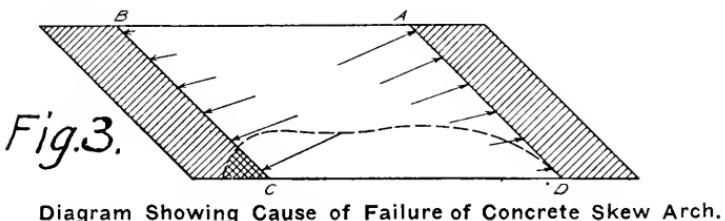
Diagram Showing Cause of Failure of Concrete Skew Arch.

ferently from concrete or reinforced concrete arches. In monolithic arch rings the ribs, of which the arch is assumed to be made up, cannot deflect independently, hence the tendency for the thrust to take a different course. In arches made of blocks, if there is not cross bonding, the several rings or ribs are freer to deflect independently.

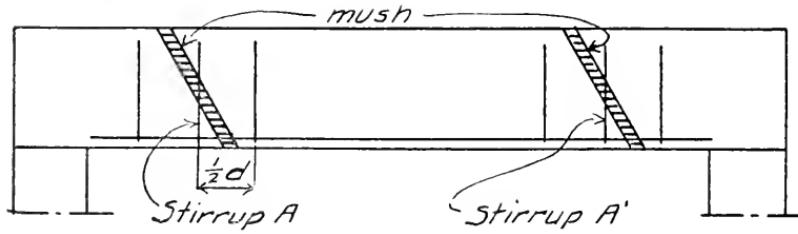
Fig. 8.

Fig. 8 illustrates this. At the left end of the beam stirrup A will be in compression, and it will be compelled to take the full shear of the beam, if the layer of "mush" is inclined as indicated; not half the shear as standard analysis has it. At the right end of the beam stirrup A', identically conditioned with A, will be in tension, the full shear of the beam.

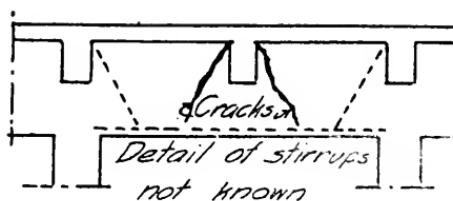
Failure No. 2 is a beam and slab type of design with stirrups and bent-up-but-not-anchored rods. It was occupied for some time and large open cracks developed in the girders, as shown in the following illustration.

I interviewed one engineer and had access to the report of another engineer who investigated this failure. They stated that the load on the floors was only what was intended by the designer to be placed on them. The excellent photographs showed no tension cracks in the bottom of the beam, but great open diagonal tension cracks in the concrete web.

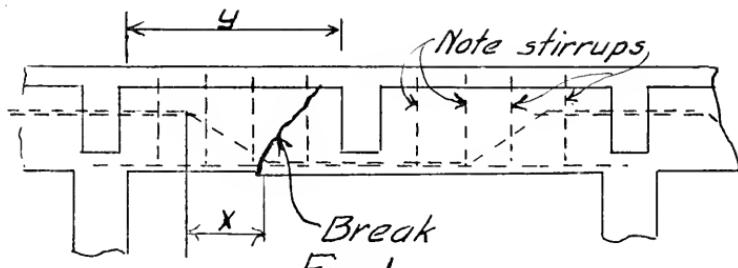
A constructional blunder is frequently made in the placing and shaping of the rods. This is to bend the rods from the top to the bottom of the slab with a sharp inclination. This is supposed to be to take the shear; but shear does not confine itself to any specified line or section either in a slab or beam. Shear exists wherever a load is being carried from a beam or slab to the support, and any system of reinforcement that fails to take account of this fact is erroneous in its conception. This error is one piece with the error of the stirrup, the short shear member, and the sharply bent up portion of the main rod in a beam; the only standard method of reinforcing for shear.

Typical Failure - Edison Building

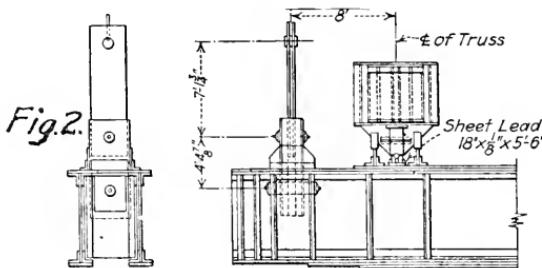
Fig. 2, was published in connection with a letter of mine in *Engineering and Contracting*, Oct. 25, 1916. The condition of this shoe on the rocking girder was similar to a pail that is hinged just above the center of its height or of one who sits on a swing and attempts to hold himself from tilting by grasping the rope near the seat.

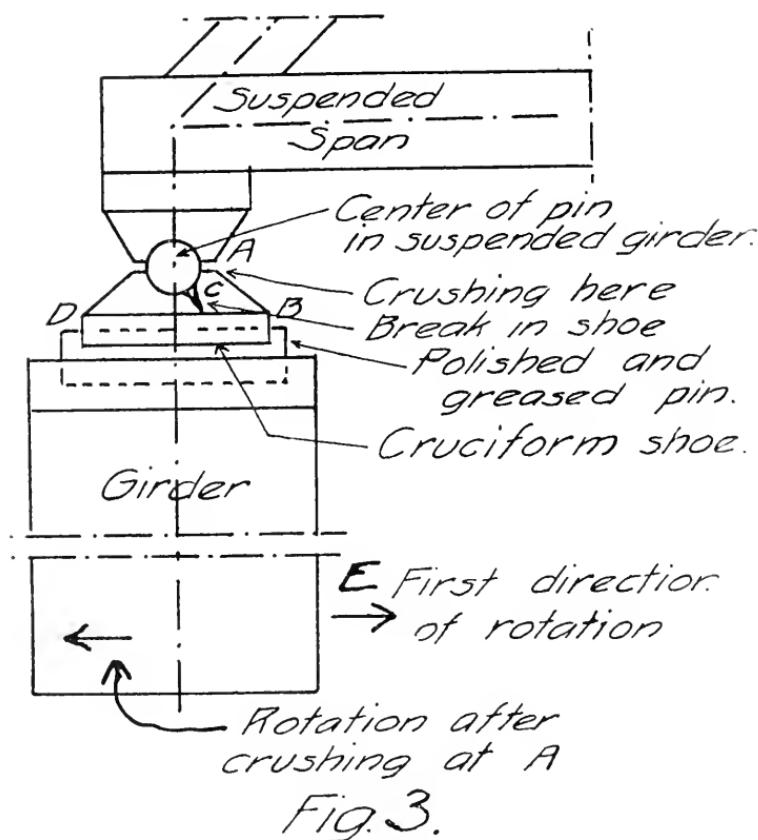
The breaking of the cruciform steel casting between the pins is easily explained. After the girder had rocked through a small angle the shoulders of the upper and middle shoe would come together at A, Fig. 3. The pres-

sure on the small surface in contact would be enormous, as it would be a line contact. This great pressure could readily crush and break the casting. It is said that the shoe of the suspended span slipped off in a diagonal direction. This can readily be accounted for by assuming that the first contact between the shoulders of the shoes was at one corner. It is also said that stop plates at B (toward the suspended span) on the shoe which failed first were not broken off while those at D were broken off. If it is assumed that the first rotation of the girder was in the direction indicated by the arrow at E, and that the cruciform shoe was broken by crushing at A and rupture at

C, the load would immediately be transferred to the right side of the center of the girder, and this would reverse the rotation indicated at E, causing the bridge to slip off on the right hand side of the girder.

There is every reason to believe that this violation of the principles of equilibrium and stability was the cause of the wreck of this span rather than insufficient strength of a heavy steel casting which would, from known principles of the action of steel, have adjusted itself even to theoretical adverse conditions by its toughness and by deflection of the parts. There was enough

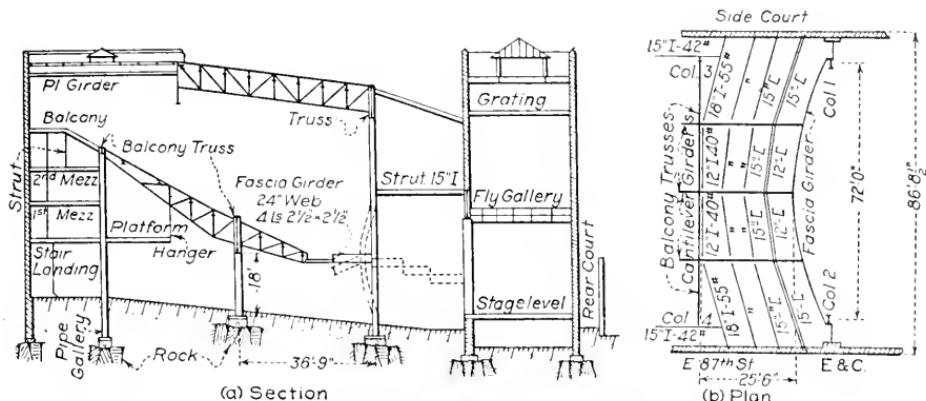
Another type of instability in steel work was illustrated in the failure of the Orpheum Theater in Brooklyn, N. Y. This happened in 1913 and is described in *Engineering News*, Jan. 30, 1913. Reports as to its cause appeared about a year later, but none of these reports mentioned the great structural blunder in the design. This theater is shown in Fig. 4, a sketch published in *Engineering and Contracting*, Feb. 18, 1914, in connection with a letter of mine. A large facia girder having a span of 72 feet and an offset of 12 feet was supposed to carry the front of the balcony on which a concrete floor had been laid. This girder flopped down and bent the columns to which it was connected, two slender columns carrying the roof. This brought the

Fig. 4. Section and Part Plan of Orpheum Theater, New York, Showing Type of Construction and Manner of Failure.

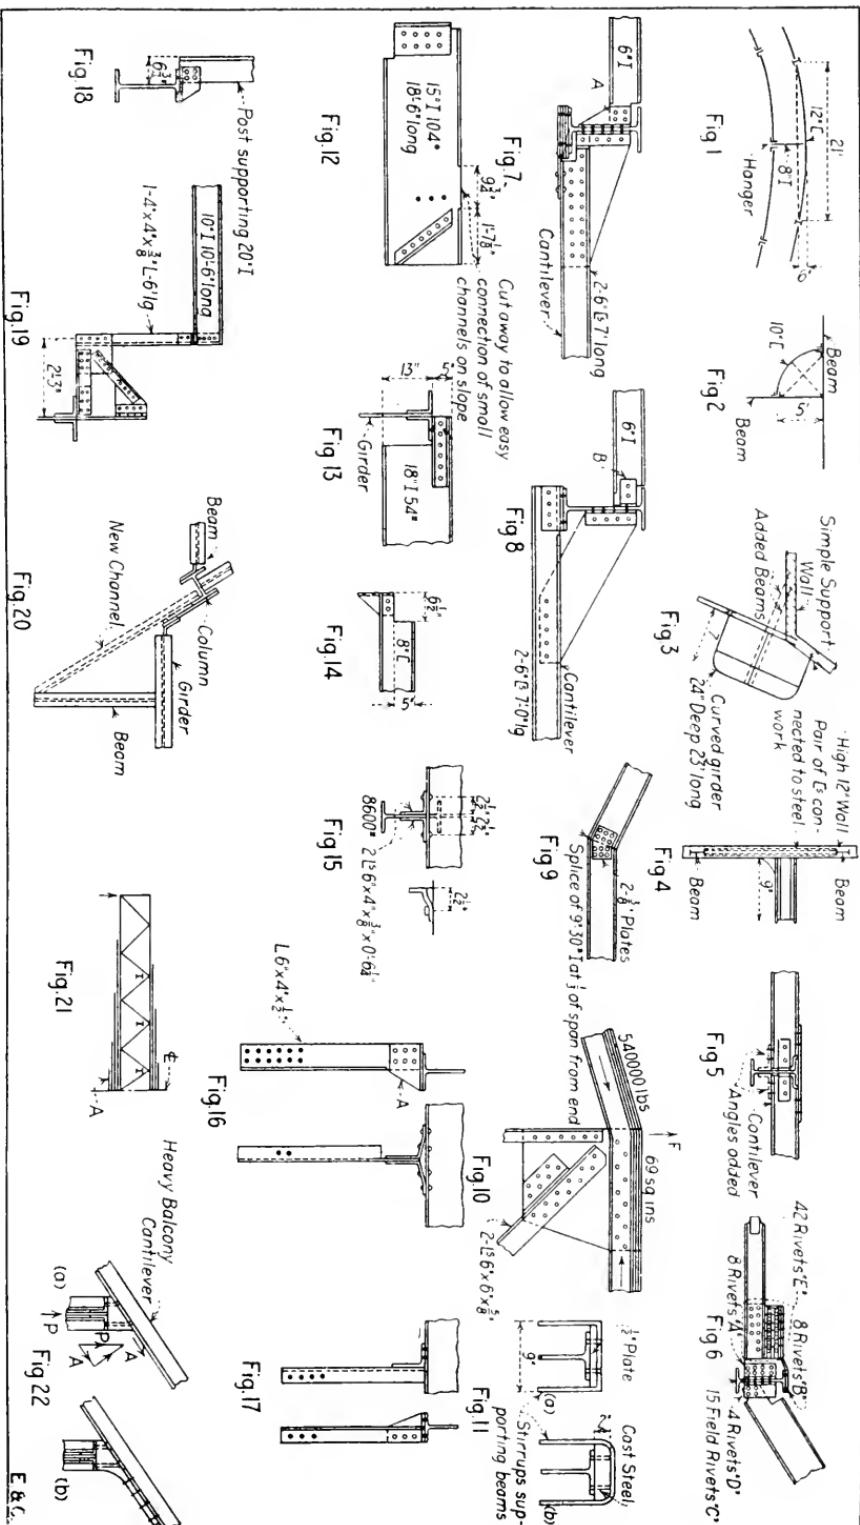
Figure 2 shows another sample of a curved beam which is even worse than the first. This beam was to carry a portion of floor and a wall. The designer marked this 10-in. channel to have "stiff connections," as if stiff connections would relieve the wrenching effect on the beams to which the channel is connected. A curved beam is in reality a cantilever, but here is a cantilever

Figs. 1-22. Examples of Errors Found in Checking Structural Steel Designs.

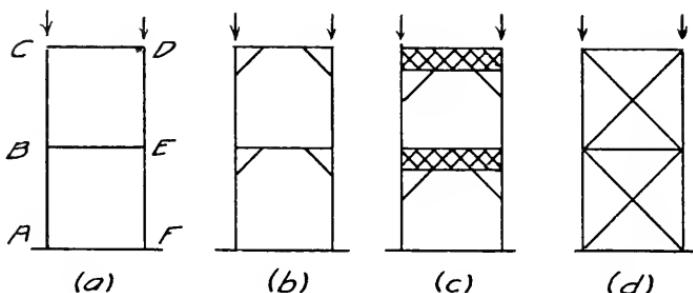
Fig. 1.

In Fig. 1 the two columns at (a) have an effective length equal to A C. (It is assumed that the tops of the columns are held against horizontal displacement.) At (b) it would appear that the knee braces would shorten the effective length of the columns, but here is another error in design very often made. Unless the strut itself is capable of taking bending stress, these knee braces add but a trifle of stiffness to the columns. If the knee braces met at the middle of the strut, a triangular system would exist, and substantial rigidity would result.

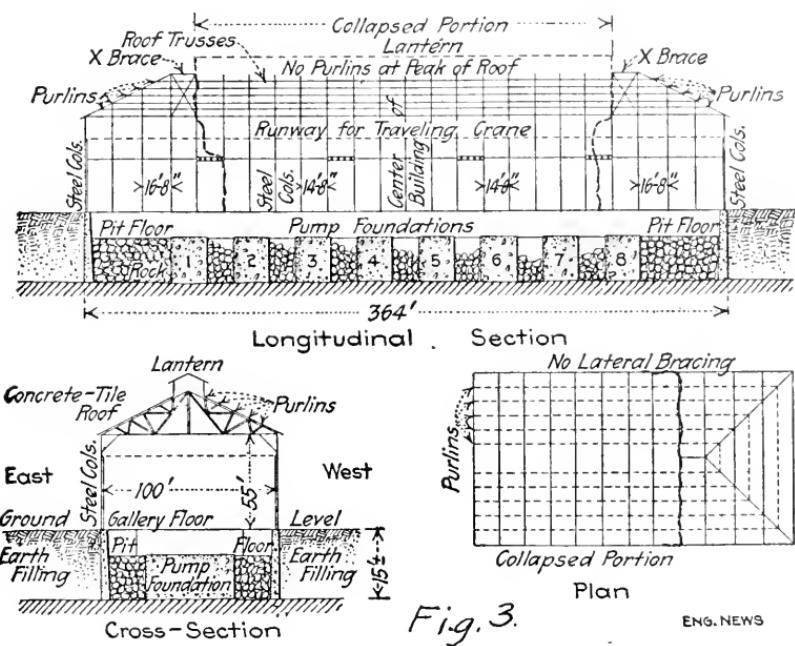
Fig. 3.

The great coliseum building in Chicago was being erected and a long row of large trusses was standing without being braced. The trusses fell over in ruins. The same building was being reconstructed and a long row of trusses had been erected. Attempt was made to slide along a beam by means of a line attached to one of the trusses, and the entire line of great trusses was pulled down the second time.

A theater building in Brooklyn, N. Y., failed in a similar manner. The line of trusses fell over because there was nothing to hold them upright.

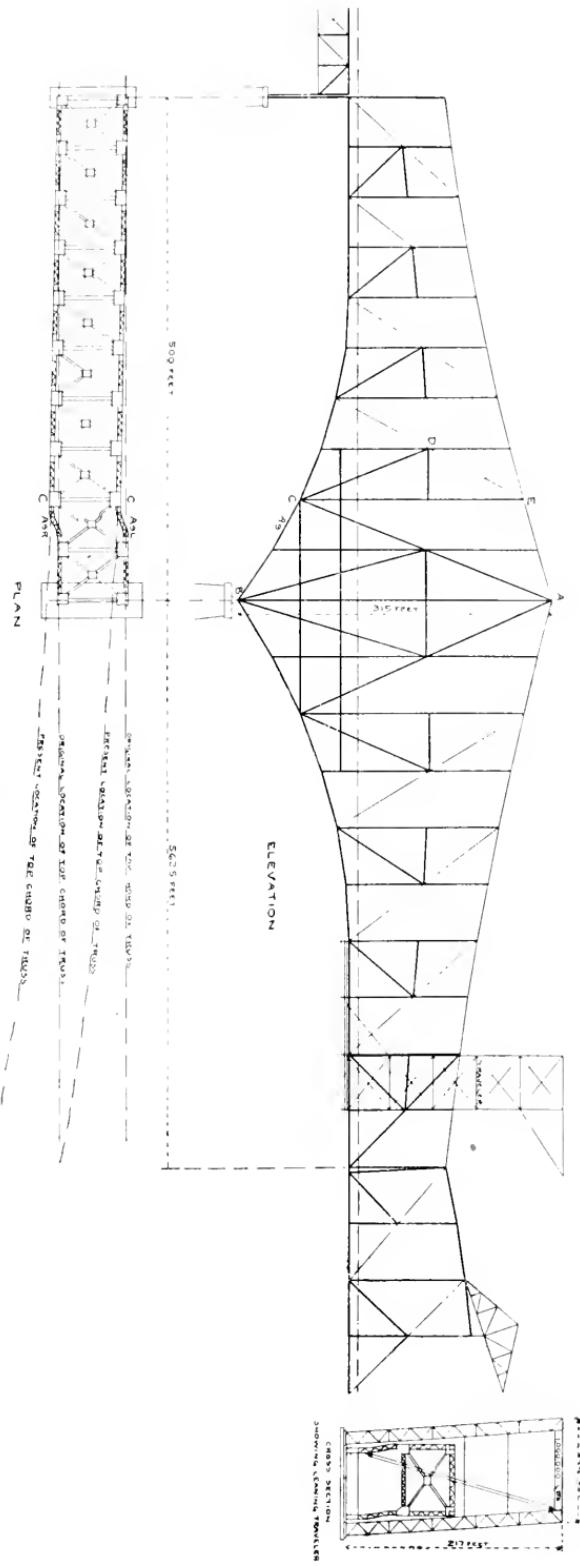
Fig. 4

In the matter of eye-bars the lesson is an encouraging one. Of over 700 eye-bars examined, only one was broken, and this was manifestly due to the fall and not to stress. The absolute reliability of upset forged eye-bars as tension members under reasonable unit stresses was demonstrated.

In a drawing accompanying this paper I have endeavored to show how this failure occurred. If there is anything regarding the failure that does not fit exactly into this theory, I have not heard of it.

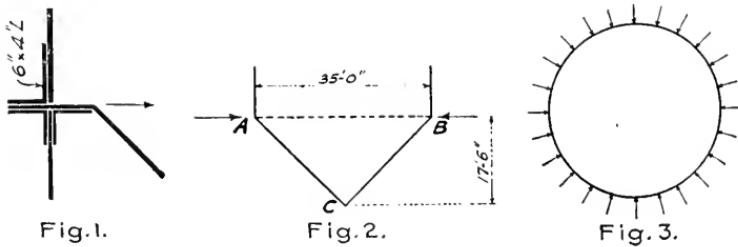
In 1901 a large water tank at Fairhaven, Mass., collapsed. The tank proper was 35 ft. in diameter and 50 ft. high. The bottom was in the form of an inverted cone for two circumferential courses of plates, then changed to a spherical form composed of a single plate. The total depth of the bottom was about 12 ft. (See *Engineering News*, Nov. 21, 1901.)

Figs. 1, 2 and 3 are sketches published in *Engineering News*, Jan. 2, 1902, in connection with a letter which I wrote to the editor. The following quoted from that letter is believed to be a complete explanation for the entire behavior of the tank and its collapse.

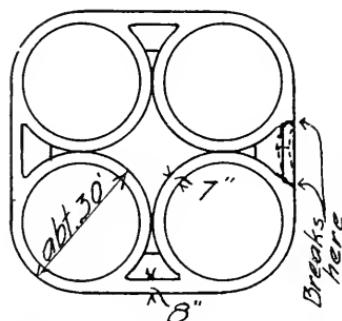
Bins about 90' high
Fig. 4 Plan of Grain Elevator
at Springfield O. Showing
Collapse of One Bin

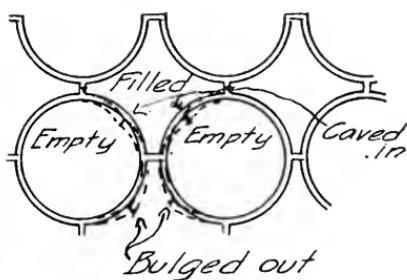
Fig. 5. Grain
Elevator at Duluth
Showing Collapse of
Star-Shaped Space

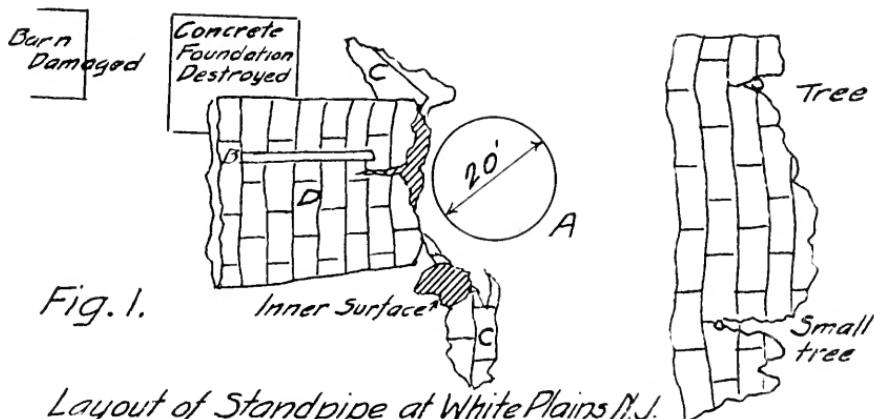
Fig. 1.

In 1909 a stand-pipe at White Plains, N. Y., failed. (See *Engineering News*, Oct. 28, 1909.) This stand-pipe was 20 ft. in diameter and 80 ft.

Layout of Standpipe at White Plains N.J.
after the Failure of Oct 20, 1909

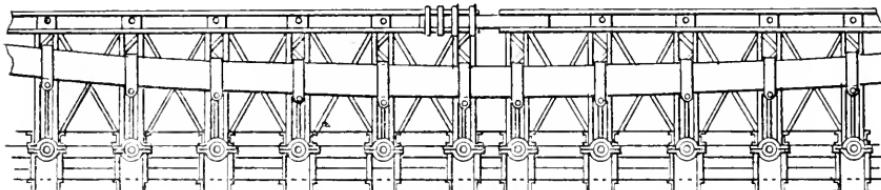
Sketch Showing Broken Suspender Rods on Brooklyn Bridge Fig. 3

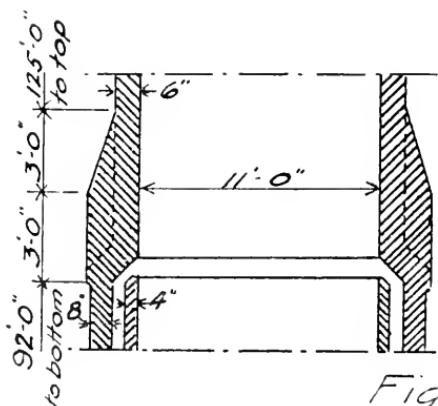
Fig. 1 shows the section of a portion of a reinforced concrete chimney which failed. This is described in *Engineering News*, Oct. 11, 1906. The figure shows a section of the shell at the offset. As seen there was a sharp offset of 8 inches in the outside shell. The offset is here designated as sharp because of the fact that the concrete or mortar to the left of the line A-B-C was simply plastered on after the forms of the shell proper were removed. The chimney broke at this offset. It is characteristic of chimneys of this design to show signs of weakness or to fail at this offset. Some have bulged out and developed vertical cracks below the offset. The fault in the design is not difficult to see.

Sketch showing
General Dimensions
of Reinforced
Concrete Chimney
at Peoria, Ill.,
that Failed
Sept. 29, 1906.

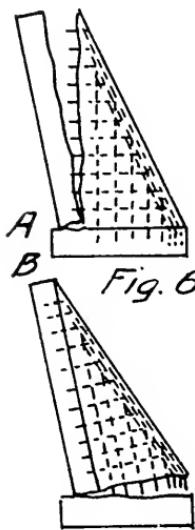
Fig. 6

"Fig. 6 shows the two ways in which one of these retaining walls could fail. The real strength of all this mass of steel rods is merely the little anchorage value of the short ends that are embedded in the vertical and the horizontal slabs. It is a cardinal principle of good design in reinforced concrete that a short end of a rod is entirely inadequate to anchor it for its full value.

"Another glaring fault in the common method of design, illustrated in Fig. 6, lies in the useless intermeshing of the rods. A single curved rod running from the horizontal to the vertical slab and anchored in each would perform all and more than all the duty that a horizontal and a vertical rod, as shown in Fig. 6, can perform. The long rods lying near vertical and horizontal slabs are absolutely useless for the greater part of their length. Single short rods from one slab around to the other, with end anchorage in each, would be far more effectual than the pairs of long rods.

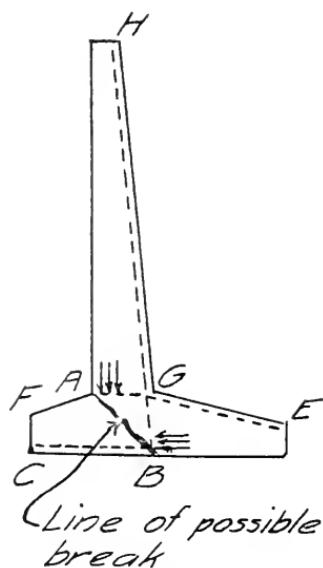
Following the article above quoted there were some letters published in *Engineering-Contracting* criticising my statements. One critic aimed to show that a cantilever retaining wall is more economical. I replied by showing by analysis some serious faults with a common form of cantilever retaining wall, the one shown in Fig. 8.

The wall shown in Fig. 8 has several objectionable features. The rods A G E and H G B have but little anchorage beyond the point of their maximum stress, namely at G. It was contended that these rods are embedded in concrete in compression and hence the anchoring value was enhanced. This is an error, as the concrete in the neighborhood of G is in tension. This is the point of greatest intensity of tension in the whole wall. For more than half of their embedment these rods are in concrete that is subject to tension. In any event the idea that concrete in compression will hold a rod with greater force than that which is subject to no stress is far-fetched and purely theoretical. Concrete is not like rubber, that it can be squeezed down to take a better hold on embedded steel.

But there is a serious weakness in the design shown in Fig. 8, that analysts have so far failed to point out. When compressive or tensile stresses must take a sharp turn, some provision must be made to take up the resultant stress dividing the angle at which the two stresses meet. The compressive stresses of the two cantilevers meet at the outer corner of this L, and there is no provision to take up this component, excepting tensile and shearing strength of the concrete. The sketch shows how and why it could easily fail. The failure would leave all the steel reinforcement intact and would be purely by tension and shear in the concrete. The arrows show the compressive stresses that are not provided for. They act against the concrete block ABCF. In addition to these stresses there is tension on the lower half of the surface A B due to the upward load on the cantilever CB. This would help to break off the block ABCF. Besides this there is a shear on the surface A B amounting to nearly the whole upward force against the base of the retaining wall. This little block of concrete is working against great odds and has large responsibility. It is not much wonder that reinforced concrete has received so many black eyes in horrible failures, when so little attention is given to correct analysis in its design. In Fig. 4 this block

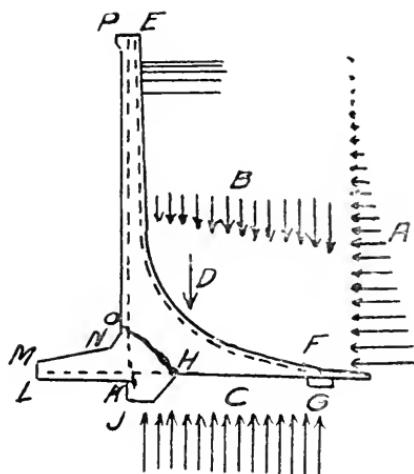
Fig. 9 shows a variation of this cantilever retaining wall. This is the section of the wall of a large reservoir in San Luis Obispo, California, which failed. (See *Engineering News*, March 16, 1911.) This sketch was published in connection with a letter of mine in *Engineering News*, April 20, 1911, which explained the probable cause of the failure and pointed out the serious fault of the design. The following is quoted from that letter:

While the wall shown in Fig. 9 is an improvement over Fig. 8 by reason of the curve on the inner angle of the L, both are faulty in the matter of reinforcement. This retaining wall with the sharp inner angle is given as standard by several well known authorities. One serious feature is that the wall is not thick enough to afford adequate anchorage for the reinforcing rods of the cantilevers.

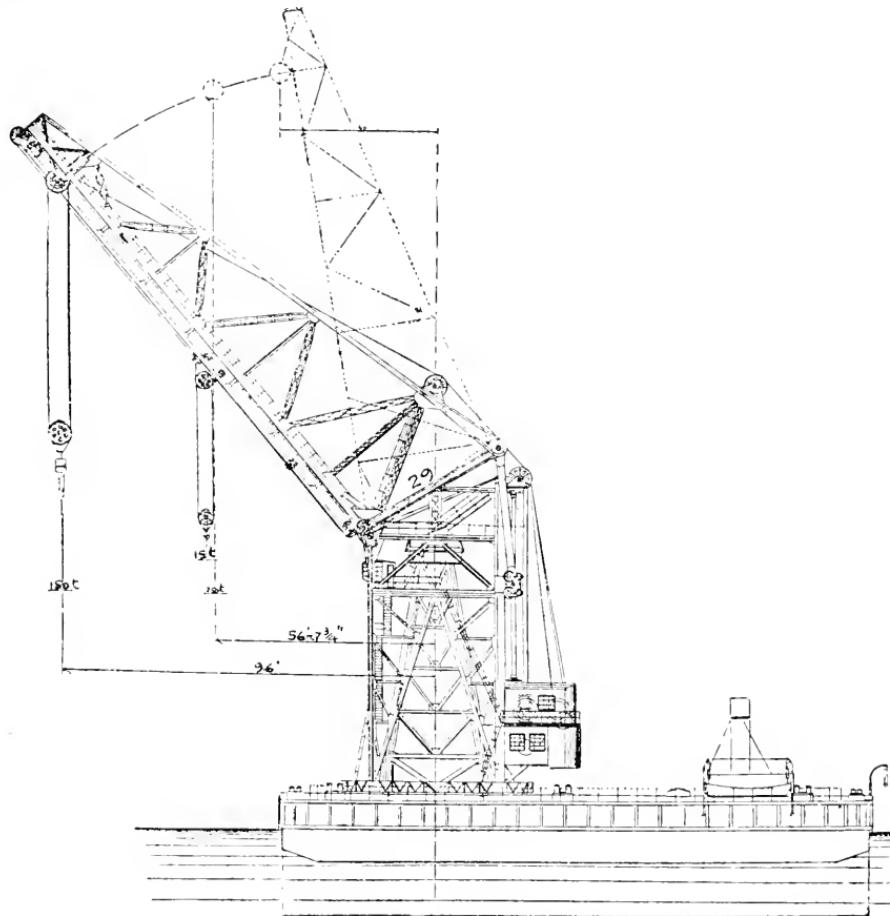
FIGURE 1.—SIDE ELEVATION OF FLOATING CRANE "AJAX."

Fig. 1 shows this crane with member 29 marked.

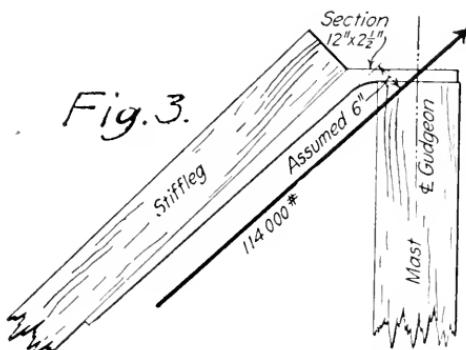
The gooseneck of a derrick failed because the bending stress on the same was too great. A letter of mine appears in *Engineering Record*, Oct. 2, 1915, p. 425. Fig. 3 is from that letter. It is seen that there is a bending moment of six times 114,000 or 684,000 in.-lb. This on the $12\frac{1}{2}'' \times 2\frac{1}{2}''$ plate would mean 54,700 lb. per sq. in. on the steel. To quote from the letter, "If the gooseneck were a tight fit on the gudgeon pin, the latter might help it out by taking a part of the moment, but this would be a precarious thing to depend upon. Attention is called to it only as a

GOOSENECK UNDER BENDING STRESS
